# Manhole Inspection Summary

Manhole # S41AA\_097MH

Insp Date: **7/29/09 9:46 AM**

**Location** Address: **700 BLK OF N CAROLINE ST** Cross Street: **E MONUMENT ST**

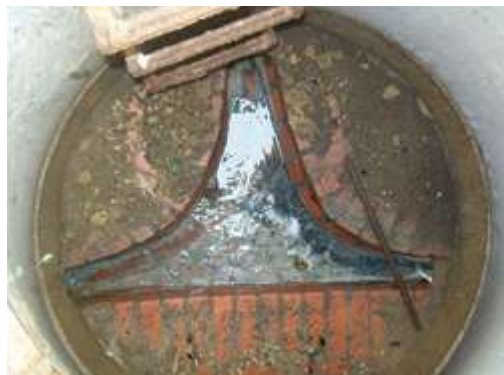
Defect 2

**Steps** Count: **3** Missing: **0** ☒ **Corroded**

corroded steps

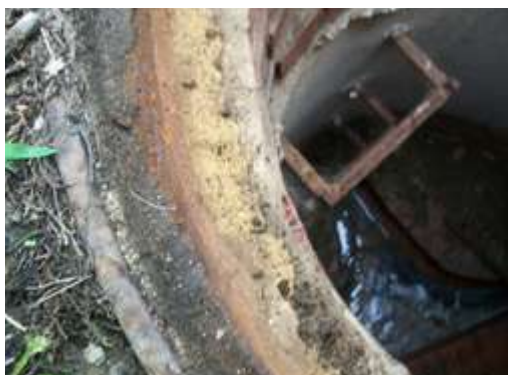
Defect 1

**Frame** Offset: **1.5** (in.) Condition: ☒ Sound ☐ Cracked ☐ Leaks

FRAME OFFSET

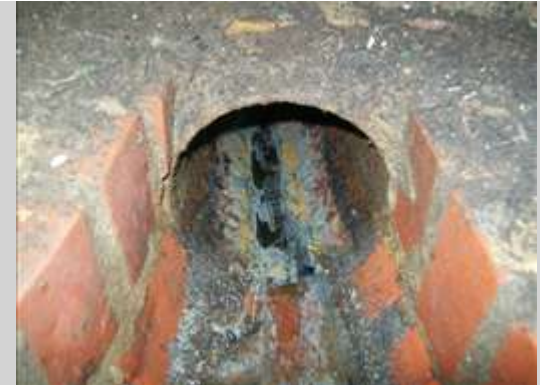
12 O'Clock Outflow

6 in. Circular Gravity Sewer  
Pipe Out @ 12 O'Clock

Pipe Height: **6** (in.) Rod and Bar (Angled)  
Pipe Material: **Clay** ☐ Pipe Lined  
Invert Depth: **5.90** (ft.) Flow Characteristics: **Slow**  
Deposits: ☒ None ☐ Mud ☐ Sludge ☐ Debris ☐ Grease  
Silt Depth: **0** (in.) Deposits Extent:  
Infiltration: **None** Pipe Seal Cond: **Sound**

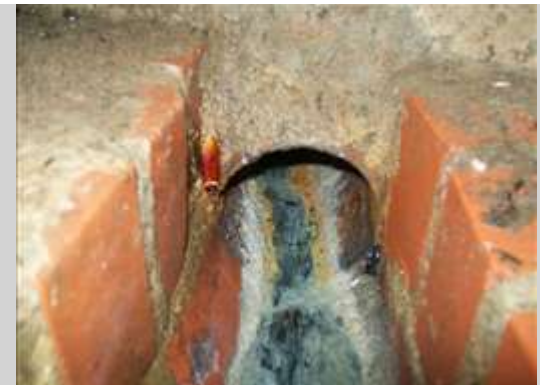
3 O'Clock Inflow

4 in. Circular Gravity Sewer  
Pipe In @ 3 O'Clock

Pipe Height: **3.6** (in.) Rod and Bar (Angled)  
Pipe Material: **Clay** ☐ Pipe Lined  
Invert Depth: **5.40** (ft.) Flow Characteristics: **Slow**  
Deposits: ☒ None ☐ Mud ☐ Sludge ☐ Debris ☐ Grease  
Silt Depth: **0** (in.) Deposits Extent:  
Infiltration: **None** Pipe Seal Cond: **Sound**

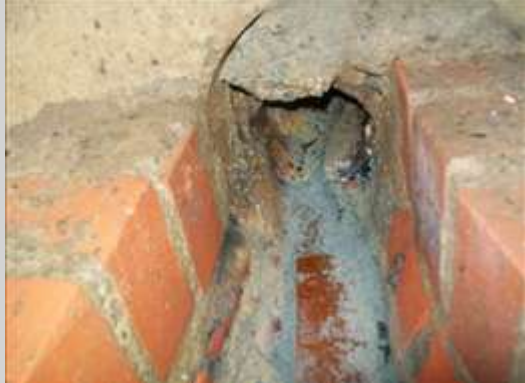
9 O'Clock Inflow

4 in. Circular Gravity Sewer  
Pipe In @ 9 O'Clock

Pipe Height: **3.6** (in.) Rod and Bar (Angled)

Pipe Material: **Clay** ☐ Pipe Lined

Invert Depth: **5.40** (ft.) Flow Characteristics: **Slow**

Infiltration: **None**

Pipe Seal Cond: **Sound**
